# **City of Cordova**

## **Multi-Building Condition Assessment:**

### **Odiak Pond Gazebo**

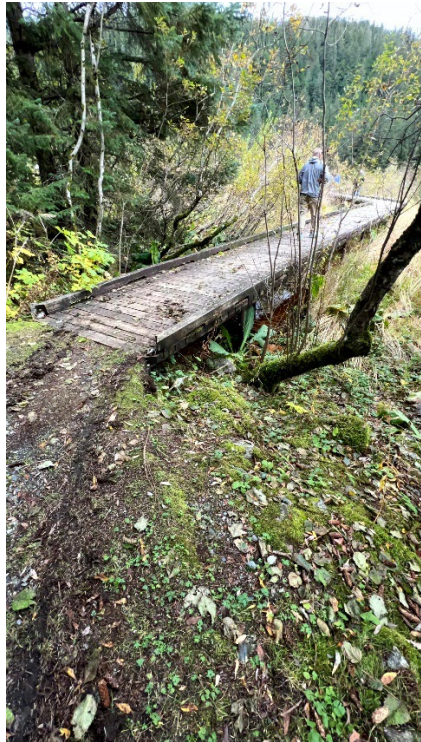
The approach to the boardwalk currently has no accommodations for ADA accessibility. The path is gravel and has some damage that prevents wheelchair access. If the City of Cordova wants to provide ADA accessibility to this amenity, the following is required.

Fig. 1. Gravel and termination at boardwalk

- ▶ Provide a 48-inch-wide asphalt walkway to the boardwalk; any height transition to the boardwalk shall be less than 1/2-inch. Any areas where slope exceeds 1:12 inches, with 1:8 maximum, handrails shall be provided on both sides of the path. Gravel path is approximately 300-feet.

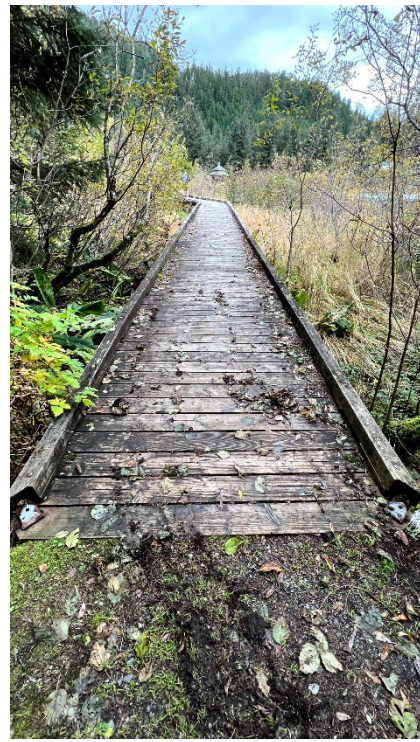
Fig. 2. Gravel and termination at boardwalk

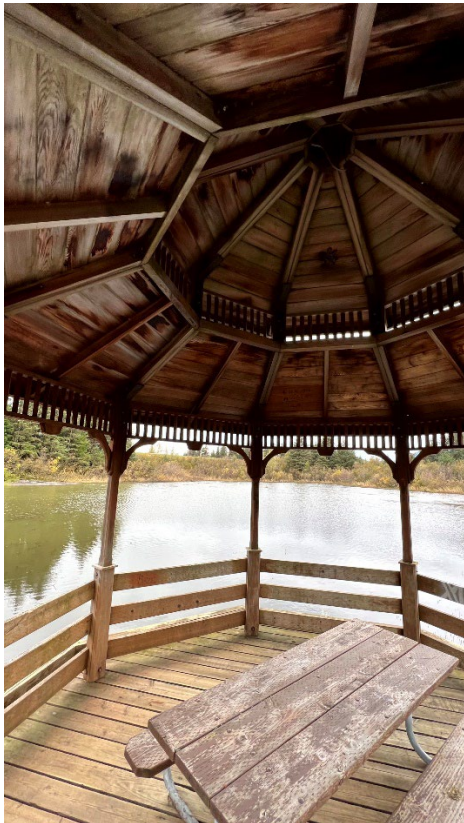
Fig. 3. Gazebo

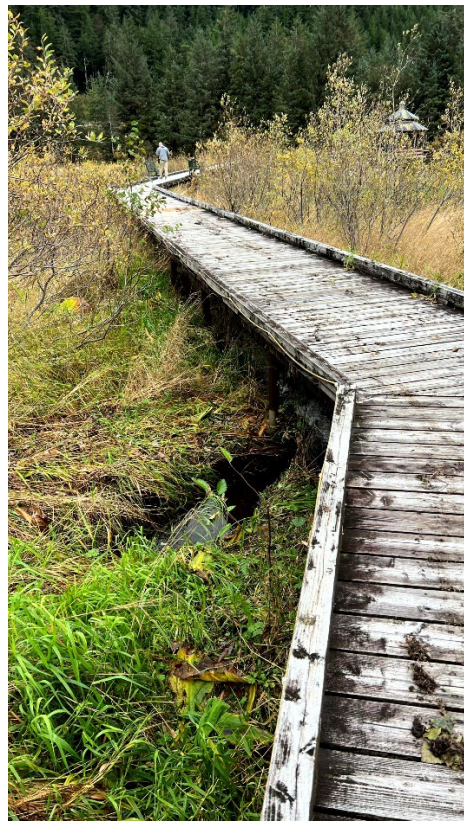
The boardwalk itself has no guards installed. Vertical drop to the water/wetland is approximately 4-feet.

Fig. 4. Typical Boardwalk

- ▶ Install wooden guardrails on both sides of the boardwalk, guards are to be constructed to 42-inches above the walking surface. Baluster openness must be maintained at 4-inches max per picket. Overall boardwalk is approximately 500-feet.
- ▶ Guards have been provided at the gazebo, but are less than 42-inches in height; provide wood buildup to increase guard height to 42-inches. Overall length is approximately 18-feet.

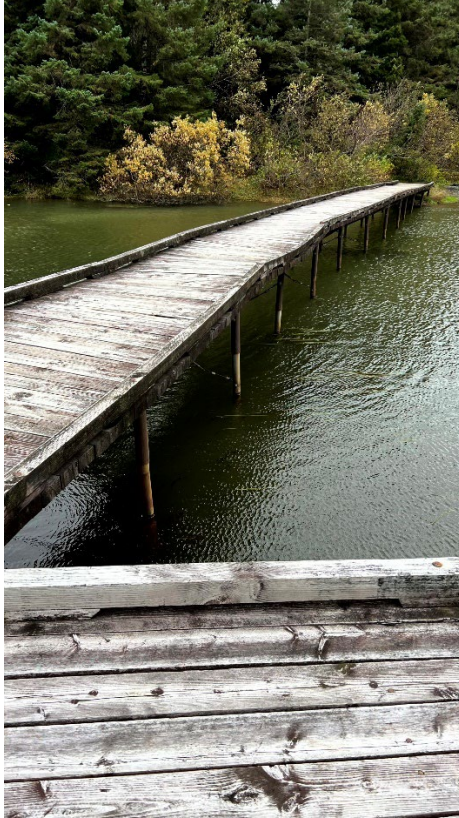
Fig. 5. Typical Boardwalk

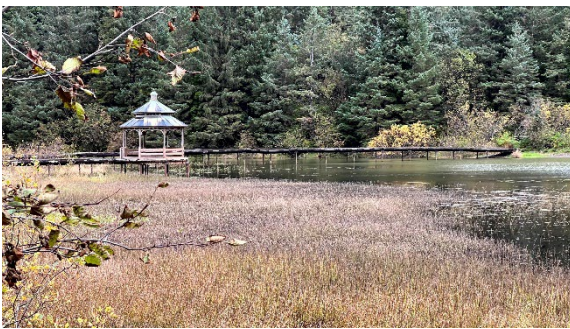
Fig. 6. Boardwalk View from North Shore

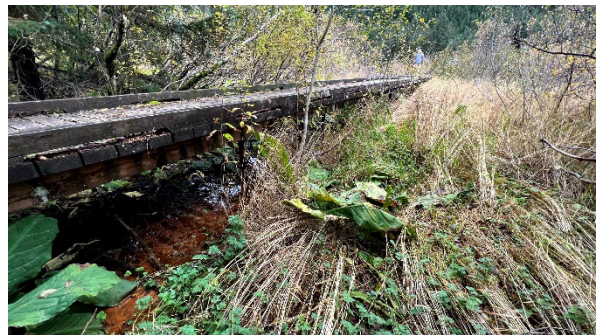
Fig. 7. Typical Boardwalk Edge

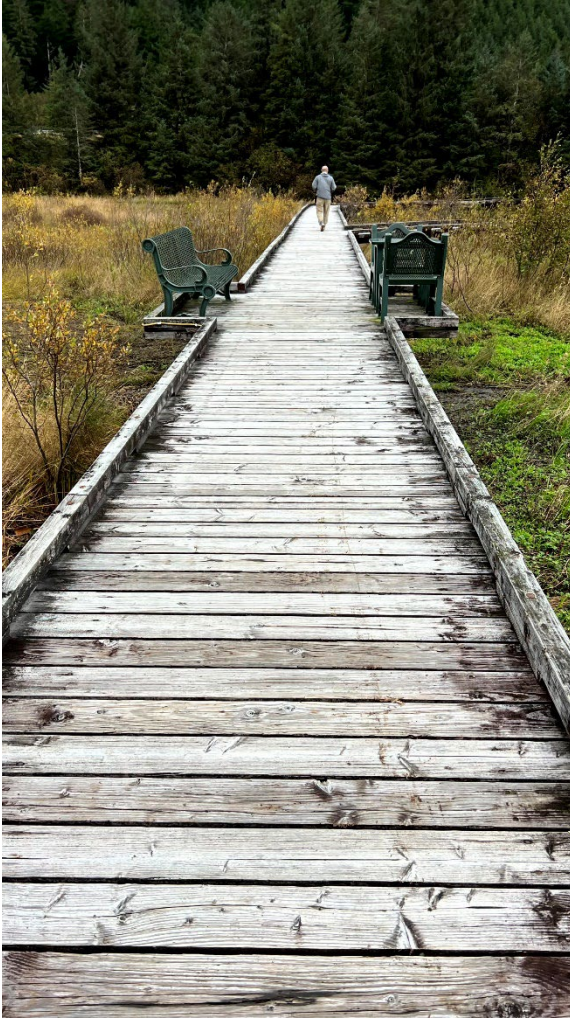
There are two widened sections of the boardwalk, one on each side of the gazebo spur deck. On the northern widened section fiberglass bench seating, table and chairs are bolted to the decking. The south widened section is absent of any seating amenities.

Fig. 8. North Boardwalk Widened Area

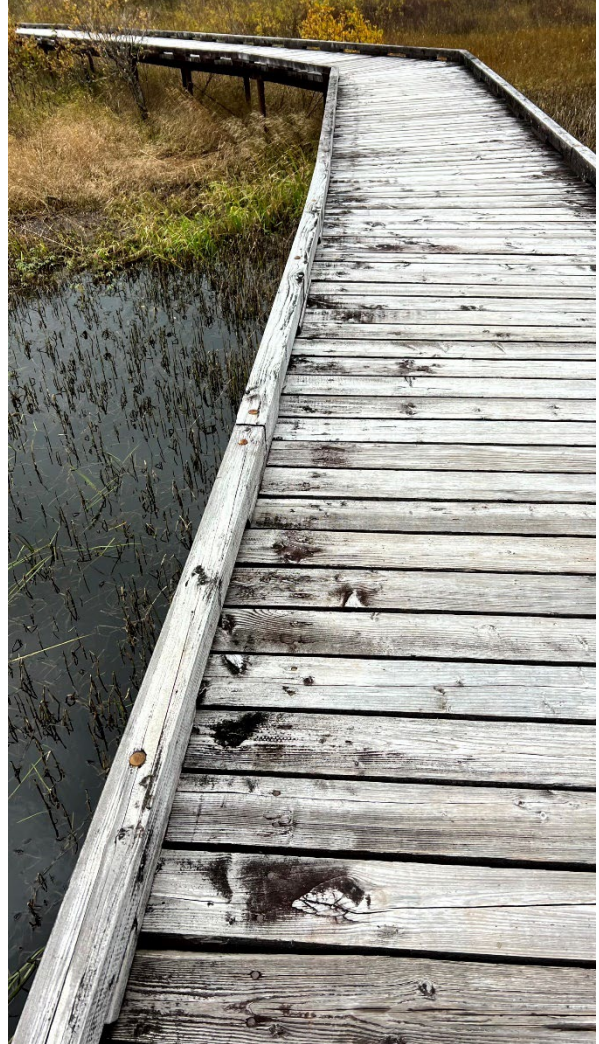
Fig. 9. Typical Boardwalk

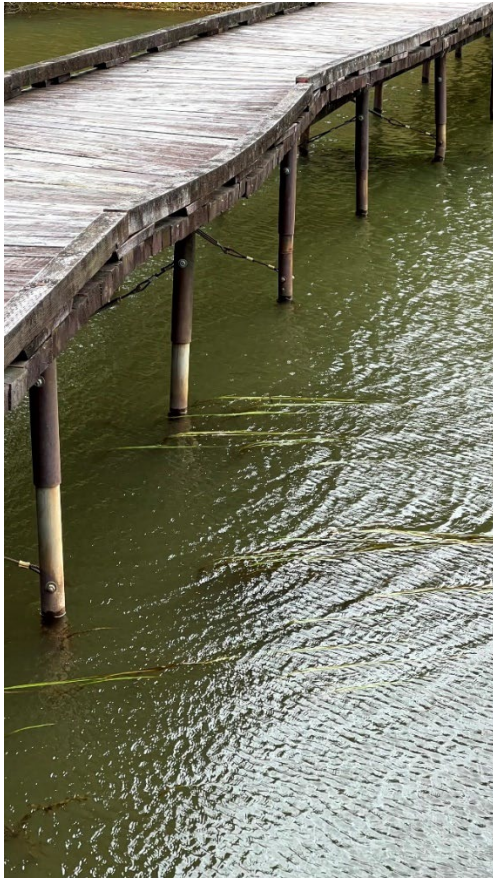
There are no guard rails along the boardwalk length or along the edge of the gazebo deck. The boardwalk surface is uneven in places where the piling has settled more than other adjacent piling. Most noticeably in the southern portion of the boardwalk and the south widened section.

Fig. 10. Sagging Boardwalk in Southern Half

5. **Relevel boardwalk.** Relevel the boardwalk using shims where possible. The larger depressions may require installation of new piling adjacent to existing.

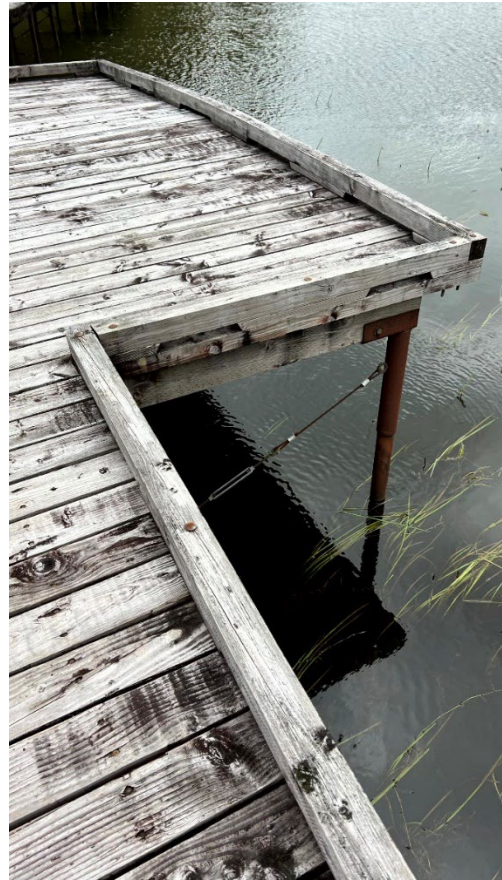
Fig. 11. Sagging Boardwalk at Southern Widened

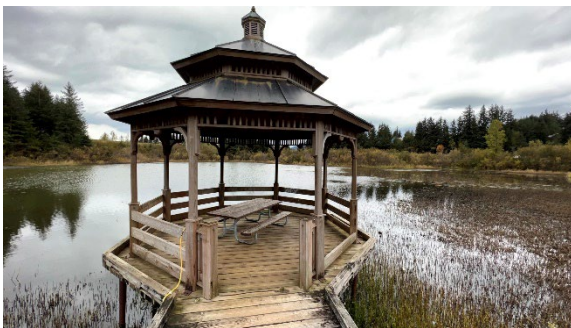
Fig. 12. Gazebo

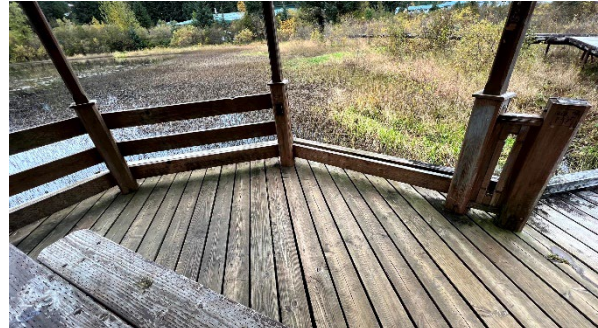
The gazebo is a manufactured wood frame structure. The floor plan is octagonal in shape with an outside diameter of 16-feet. The gazebo columns are fastened to the supporting decking with steel angles and through bolts. The structural condition of the gazebo is fair. There are three horizontal 2x8's forming a guard rail on the seven outside sides. On one side the top two guard boards are missing.

Fig. 13. Gazebo Missing Guard Beams

2. **Guardrails at Gazebo.** Guards have been provided at the gazebo, but are less than 42-inches in height; provide wood buildup to increase guard height to 42-inches. Overall length is approximately 18-feet.

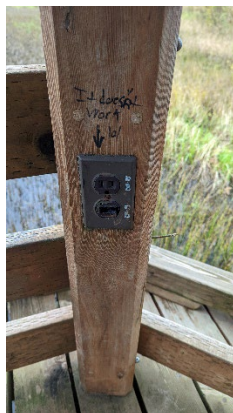
Electrical loads for the gazebo includes a duplex receptacle and wiring to the top for a light fixture. It appears both loads have no service or power. An extension cord is installed along the length of the boardwalk to the base of the gazebo. The other end of the extension cord could not be located as it transitions to below grade at the end of the boardwalk. Per discussion with maintenance, it is likely that the extension cord runs to the medical clinic. The extension cord length is estimated to be over 100 feet.

Fig. 14. Damaged Unpowered Receptacle at Gazebo

4. **Gazebo Power and Lighting.** Replace the existing extension cord to the Gazebo with conduit and wiring. Provide a GFCI receptacle with locking steel cover. Feed load from a viable circuit within the hospital. Nearest panelboard is estimated to be 200 feet away. Provide a new vandal resistant LED light fixture at the ceiling of the gazebo.
